PROSPECTING THE URBAN MINES OF AMSTERDAM

Refining the PUMA method based on findings from practice

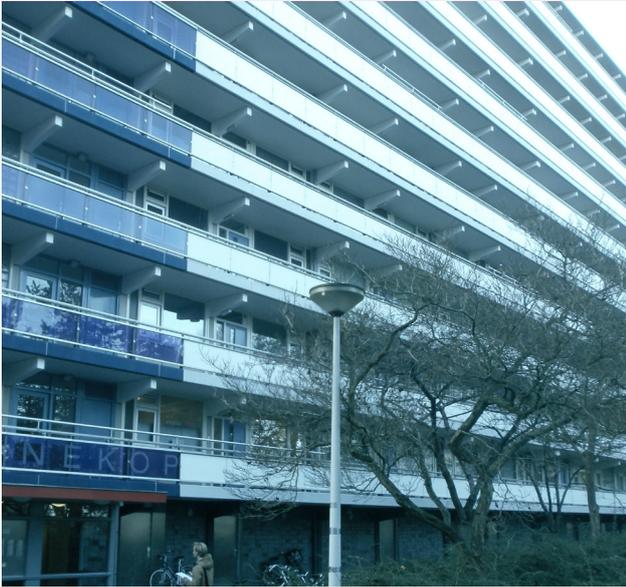
SPINNEKOP 18

Spinnekop 18 is a gallery-flat built in 1968. It measures 31.1 meters with ten floors. The residential flat counts eighty apartments, although one of these contained a physiotherapy practice. The facade contained metal in the galvanized steel and aluminum gallery railings, as well as galvanized steel rain tubing and aluminum plates on the doors and mailboxes. The bearing structure is likely to be steel-reinforced concrete and the apartments can be reached via two elevators or two stairways with steel handrail supports. The roof was not accessible, but metal chimneys and solar panel support was visible.

The 90m² apartment contained a kitchen, separate toilet, and a bathroom without toilet. The sink and tap in the kitchen were made of stainless steel, while the toilet and bathroom sink contained no metal. The central heating of the building was connected to seven steel radiators in the apartment. The copper water and gas piping was connected to the boiler, the casing of this boiler was however missing due to recent repairs. The door and window frames were made of wood and there were no visible signs of renovations in the apartment.

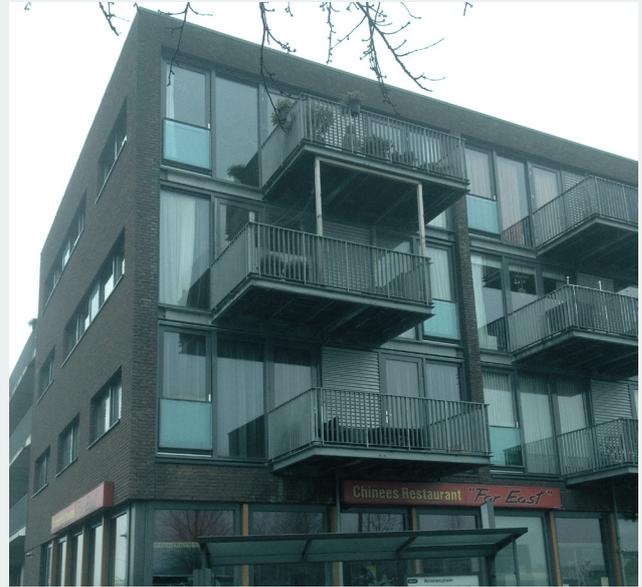
PRUIMENSTRAAT 6A

This flat was built in 2006 and contains 29 apartments, which are spread over two buildings that have a shared front door and can be reached via stairs, an elevator, and walkways. There is a Chinese restaurant on the ground floor of the building and a large parking garage and ventilated storage sheds in the basement. Other building features included shading panels in front of some windows and corrugated sheets—both aluminium. Every apartment had a balcony with galvanized steel beams and the gutters, drains, and railings of the walkways and stairs were made of the same material. Lead sheets were found at the base of the building for waterproofing.

The 80m² apartment has a kitchen, bathroom with toilet, and a separate toilet. Notably, next to the central heating with five radiators, the apartment has floor heating as well in the hallway and bathroom, totalling to approximately 17m². The apartment additionally contained a ventilation system with aluminium and steel ducts. The fuse box furthermore contained a spare copper pipe and the internal door frames were made out of steel.

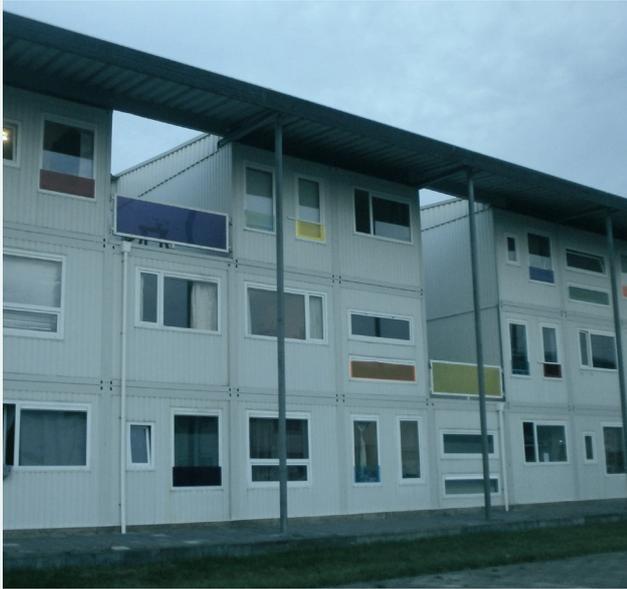
VOETBALSTRAAT 87

This flat in Westlandgracht consists of stacked shipping containers that have been transformed into small studios. The flat provides housing for young refugees and students, both of which inhabit half of the studios to promote integration. Prior to the project's realization in 2016, the containers were used for residential purposes in Houthavens, which provides a practical example of metal recycling in residential buildings of Amsterdam. The steel containers, which make up the whole load-bearing structure, can weigh between 2200 and 4150 kg each (Vantage Freight, 2013; Balk Trade B.V., 2016). The actual contribution of the containers to the steel content will be lower due to the windows, doors, and their plastic frames. The building furthermore has corrugated metal plates as roofing, galvanized steel rain tubes, and corridors between the buildings.

Galvanized steel stairs lead to a central hallway with steel doorframes through which the 78 studios can be reached. Four central heating facilities with steel piping supply the radiators in the building, of which each studio has one. The studios have a single room with a kitchen block with a steel countertop and sink, no gas connection, and a bathroom containing a boiler and toilet. There were no visible signs of renovations since the building's construction.

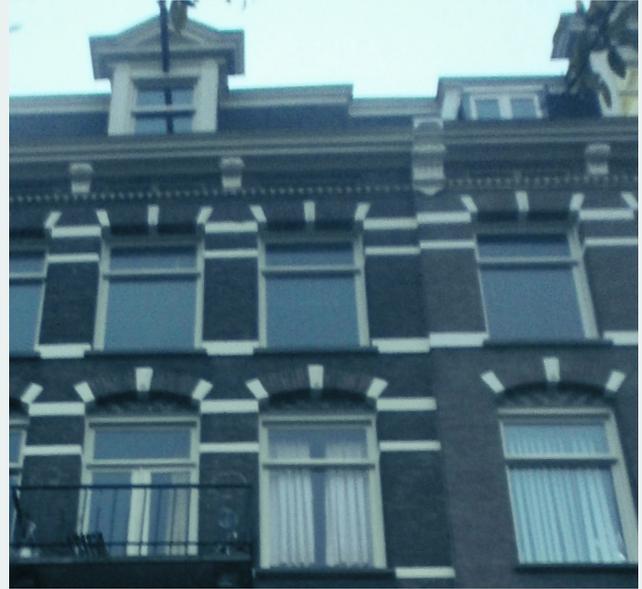
NICOLAAS WITSENKADE 12A

This canalhouse contains three apartments spread over six stories, including the basement. The building could not be dated in the BAG register, but the neighboring houses date back to the end of the nineteenth century according to the register. The load-bearing structure consists of stone and concrete bricks, and thus is unlikely to be reinforced with steel. The frames of the doors and windows are made of wood. Cast iron was found in the fences of the stairs, the four balconies, and basement windows. A steel staircase to reach the first floor's entrance was visible as well, which continues inside up to the sixth floor.

The apartment has one kitchen and two bathrooms with separate toilets, one of which has a tap and sink. An extra tap was found in the hallway and a steel tap, sink, and countertop was present in one of the rooms. The central heating is connected to eight radiators that varied significantly in size, and an extra disconnected radiator was found in the fusebox. All door and window frames were wood. The copper piping of the boiler was significantly corroded, which raised questions on its reusability. Although there were no visible signs of renovations, a large renovation is planned in January 2017 that will remove walls and integrate two of the apartments within the building into one larger apartment.

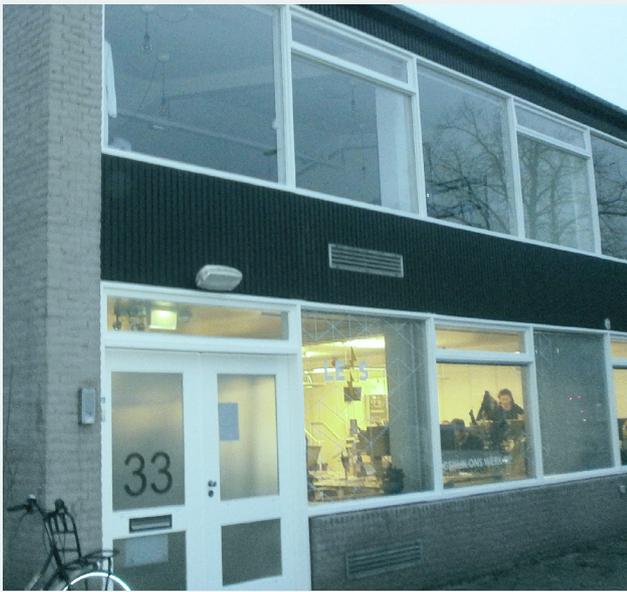
SURINAMEPLEIN 35

This five story building in Hoofddorppeleinbuurt is a former nursing home and is now a cultural incubator, providing housing to 62 people, eight rehearsal rooms and 11 ateliers and offices. Although the building's official function is still healthcare, its current use is mixed residential and commercial. Notable is that it is attached to the office space in Surinameplein 33, which is in fact not an official address and is part of Surinameplein 35 according to the cadastre. The eight balconies have steel railings and the window and door frames leading to them are made of steel. The facade contains galvanized steel drainpipes up to the first floor, from which point onwards they continue as plastic. The entrance to the building has a staircase, and two old elevators and stairs with steel railings lead up to the apartments.

Although the building contains a single apartment of 3420m² according to the cadastre, and thus in the PUMA framework as well, the floor was defined here as a functional unit for apartment during the site-visit. The findings were multiplied by five to obtain the building and apartment results to compare with the PUMA assumptions. Each floor serves as a separate large apartment, providing housing to 14 people who share one kitchen, four showers and four toilets, and every bedroom has its own tub and sink. The apartments have central heating with 25 radiators per floor. The door frames contain some steel, of which there are 28 per floor with an additional three fireproof doors. There were clear signs of renovations; five walls were removed and the kitchen infrastructure was moved to another room.

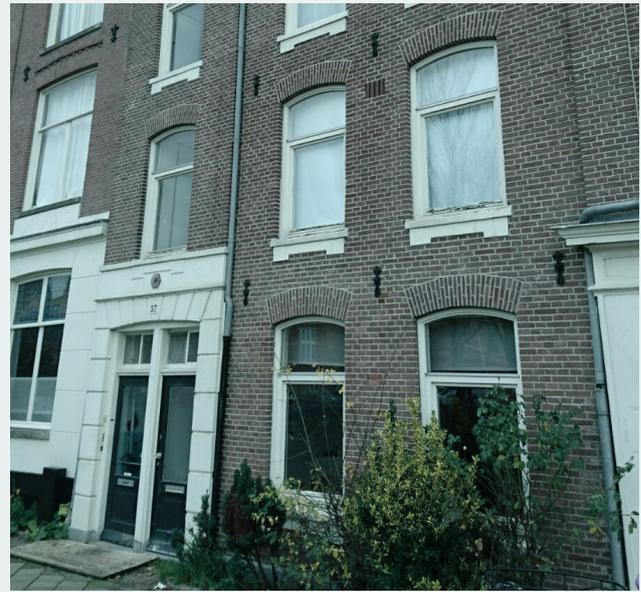
RUYSDAELKADE 57 HS

This house from 1875 in Oude Pijp is made of stone bricks for its load-bearing structure. Although the partitioning of the facade and doors suggest the presence of four apartments, the building is actually bigger and contains fifteen apartments and one gallery on the ground floor. The facade furthermore contains cast iron ornaments and galvanized steel rain pipes.

The apartment was on the ground floor and had a separate door, so no stairs leading to the other apartments were visible. There was one kitchen with a gas connection, a stainless steel sink, and a countertop, as well as one bathroom with a toilet but no sink. A separate toilet was not present. The door and window frames were made of wood. There was central heating in the apartment with four radiators. It was indicated that this heating system was recently changed, implying a renovation that might have affected the metal content.
